## Site Audit: Southchurch High School, Southend

**Author:** Pearl Barnes, SEND Consultant at SENDISS

A full site audit for accessibility and safety was carried out on **19<sup>th</sup> January 2023**

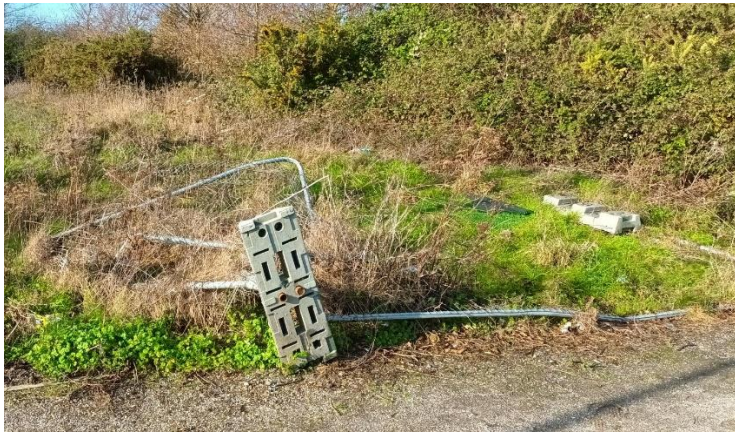
Left: Photo 1 – debris by the field and multi-use pitch

35. broken goals and posts behind the multi-use area – photo 1

46. clear the broken debris

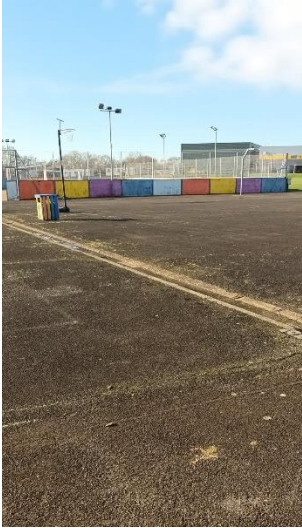
Left: Photo 5: gully – trip hazard

| | | 41. | Gully in the middle of the tarmac area is a trip hazard (photo 5) | | |

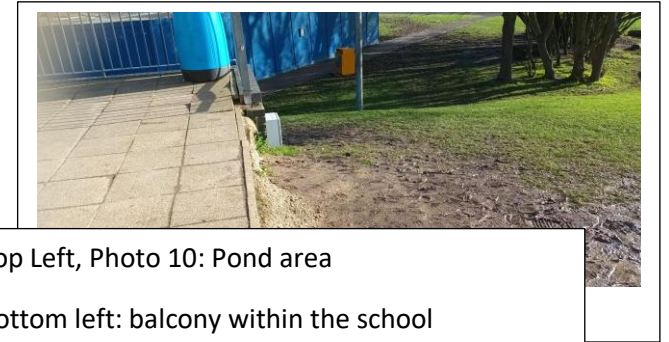
Top Right: Photo 7: Large hole in outside area

| | | 44. | Large hole in the pavement | | |

52. fill in hole in pavement with urgency
